123 Main St. Milwaukee, WI

Inspection Date:

12/28/2011

Cornerstone Home Inspection

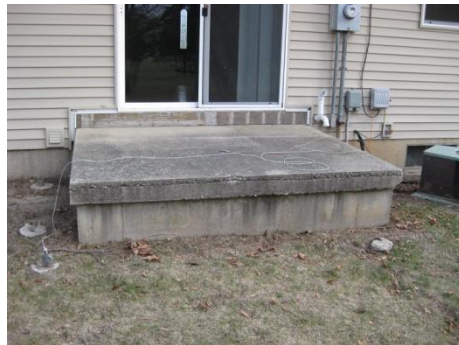
Rear raised slab does not have a step and is a trip hazard.

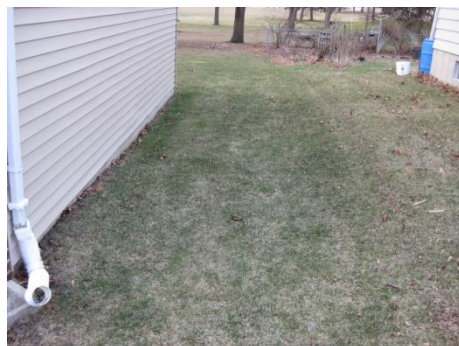
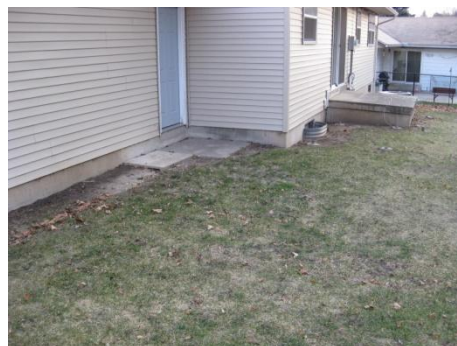
Areas on the west and south yards have negative sloping. Recommend adding fill to bring grade back to a positive slope.

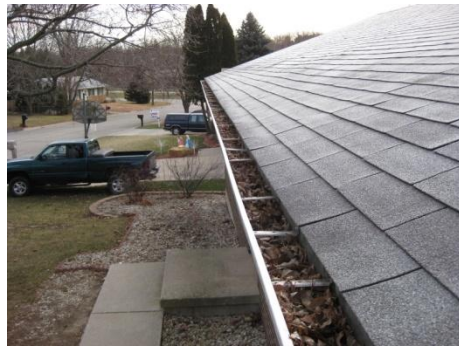
Gutters are full of debris.

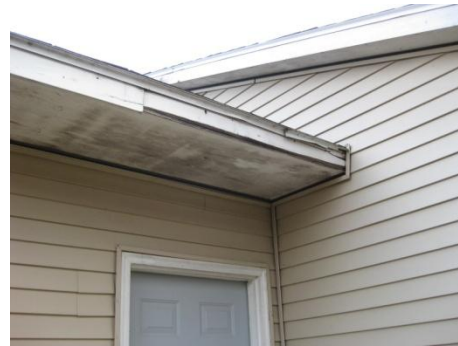
Gutters/downspouts missing on back of garage.

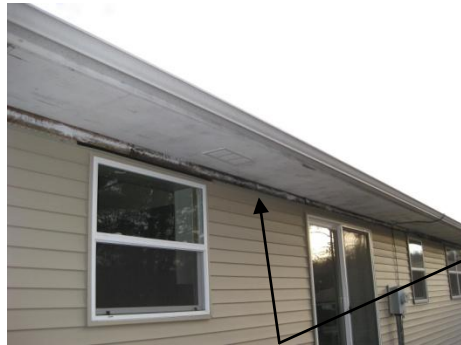
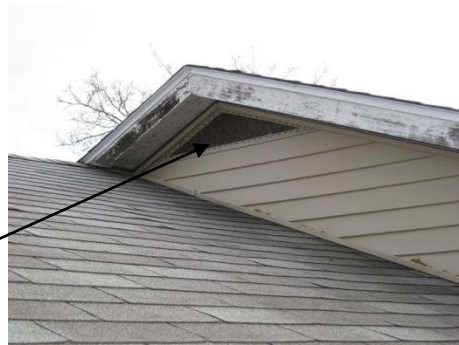
Areas of siding missing on south and west sides.

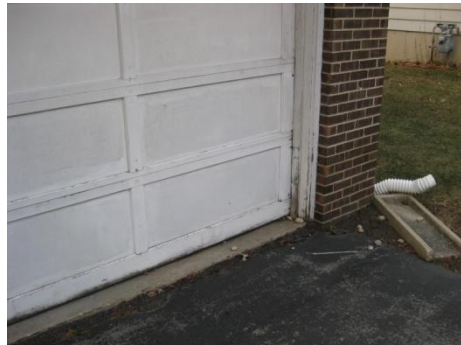
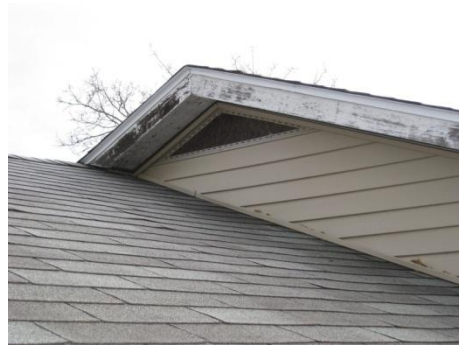
Areas of wood trim require re-painting.

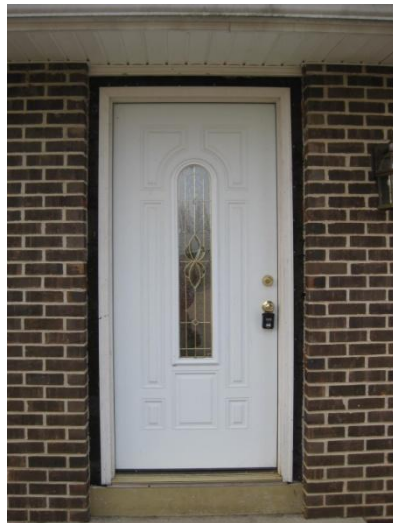
Front exterior door installation not finished.

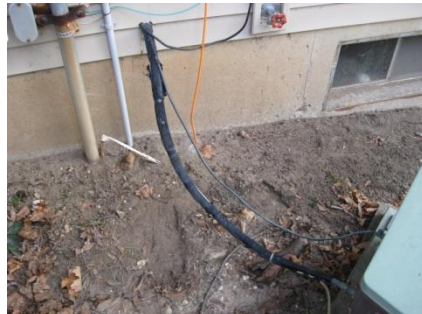
INFO Exterior A/C foam insulation is in poor shape. Handyman wiring on exterior A/C with no disconnect. Exterior A/C did not have manufacturer tag on unit so age of unit is unknown. Breaker for A/C unit in main electrical box is a 40A breaker with manufacturer recommendation of no more than 20A breaker.

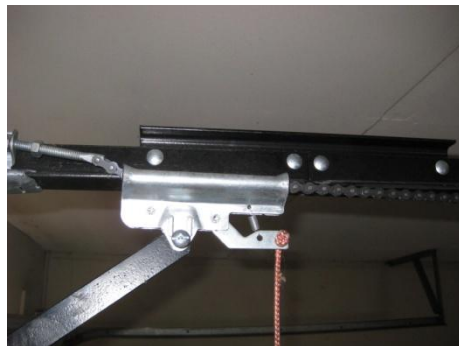
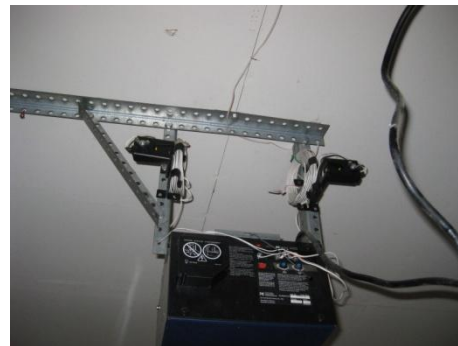
Garage door opener chain is caught on sliding unit and does not allow door to open normally.
 Electric eyes are installed improperly on opener instead of on bottom of garage door tracks.

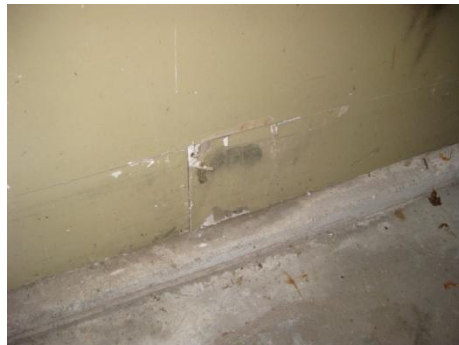
INFO Damage to drywall in garage in two areas.

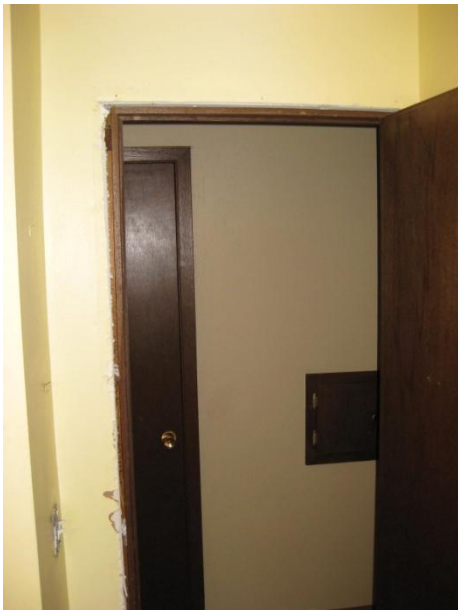
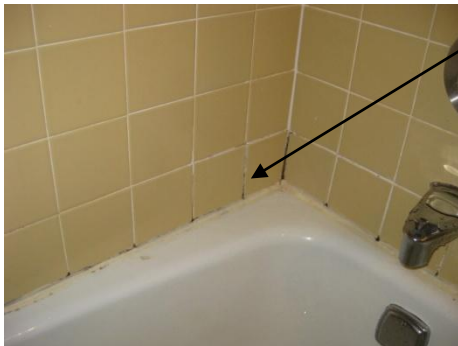
INFO Trim is missing around door and throughout bathroom. Exhaust fan switch is backward. (On is down.) Loose tiles in shower.

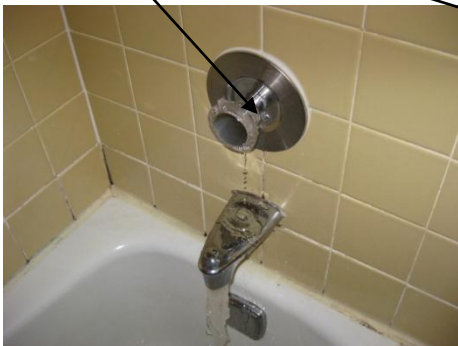
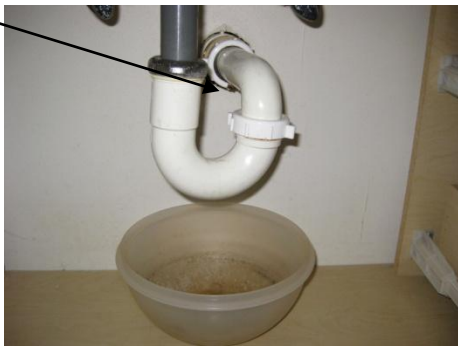
Shower faucet is leaking. Sink pipes are leaking.

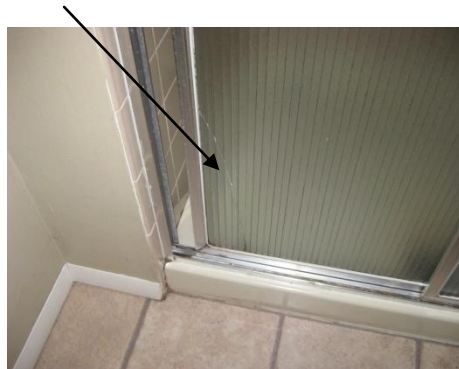
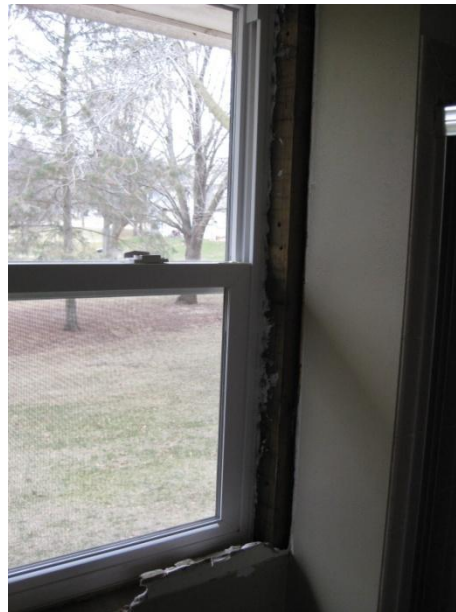
INFO Shower door glass is cracked. Window trim is missing. Trim around bathroom is missing.

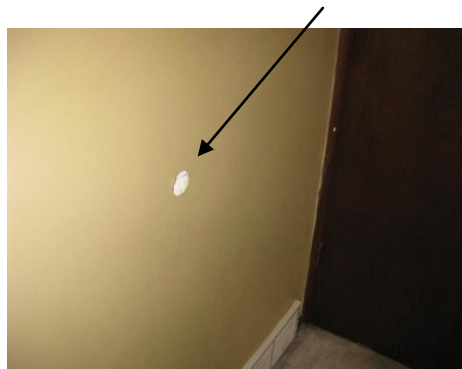
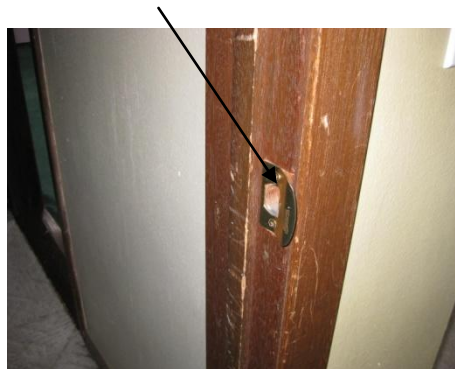
INFO South window latch is loose. Hole in drywall behind door. Door catch plate is bent and does not allow door to catch.

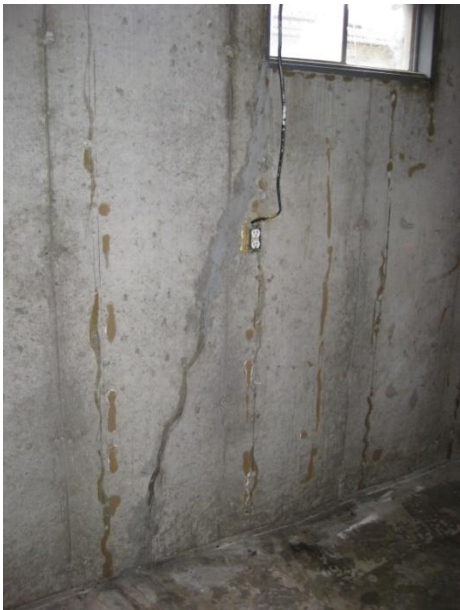
Basement east foundation wall crack.

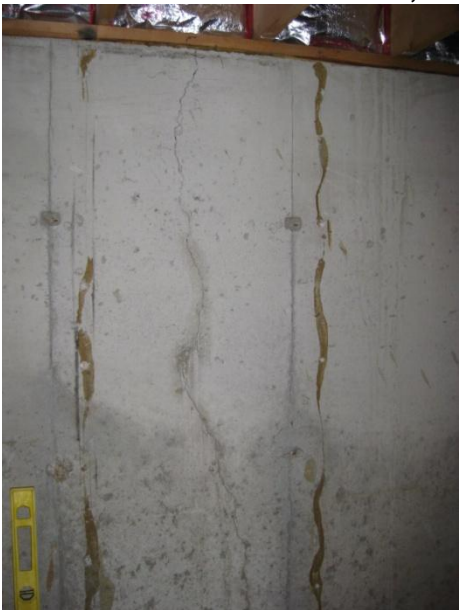
Basement foundation wall north crack.

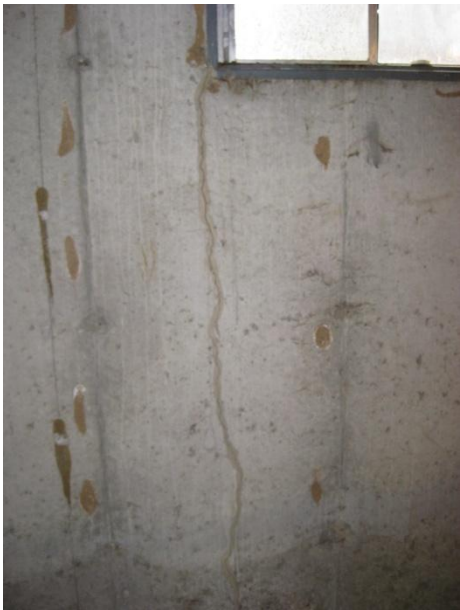
Basement south foundation wall crack. Recommend monitoring each of the foundation cracks for continued movement and further evaluation/repair if necessary.

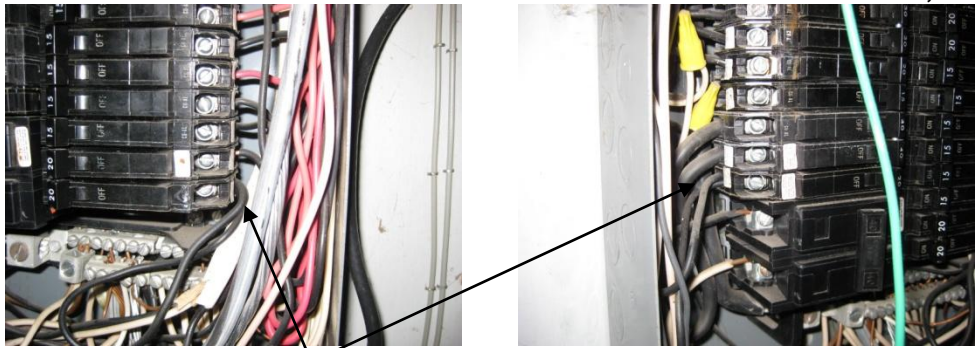
INFO Double tapping in main electrical box. Recommend repair.

Electrical double tapping.
